**December 10, 2020**

## Asbestos, Mercury, PCB & Lead Inspection Report

Washington County Courthouse  
(And Attached Structures)  
Abingdon, Virginia

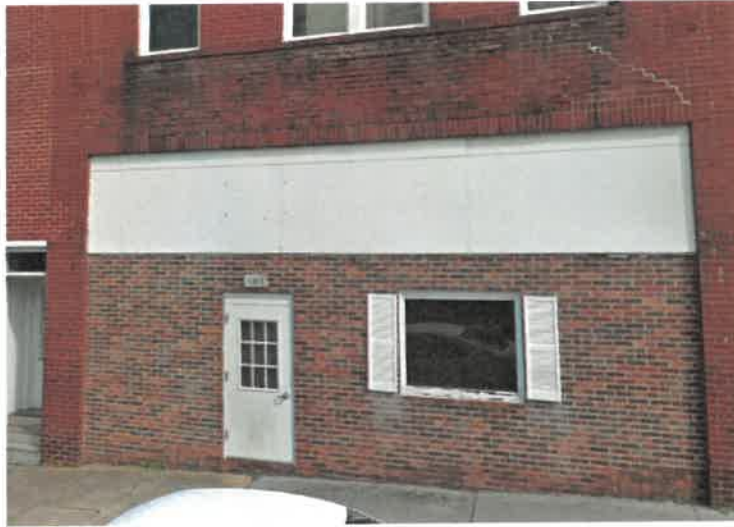
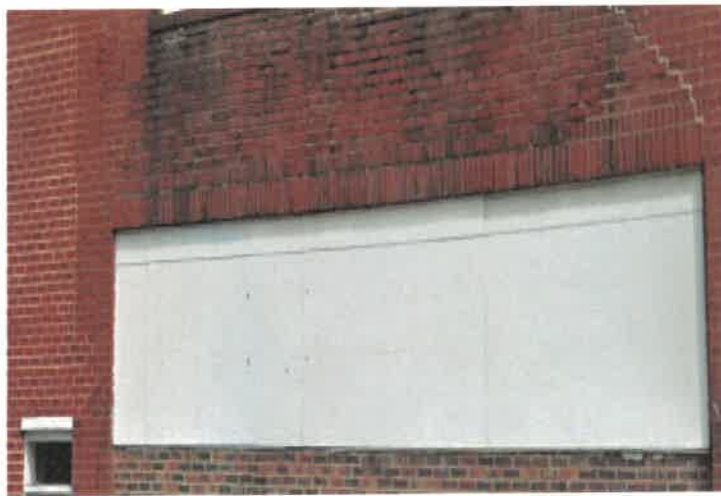
**The cement storefront panels on the Elliot Building were found to be Asbestos Containing by the laboratory.**

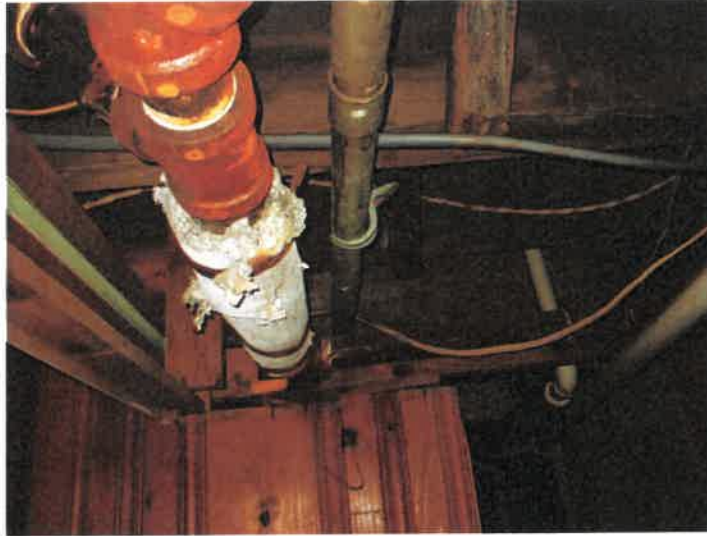
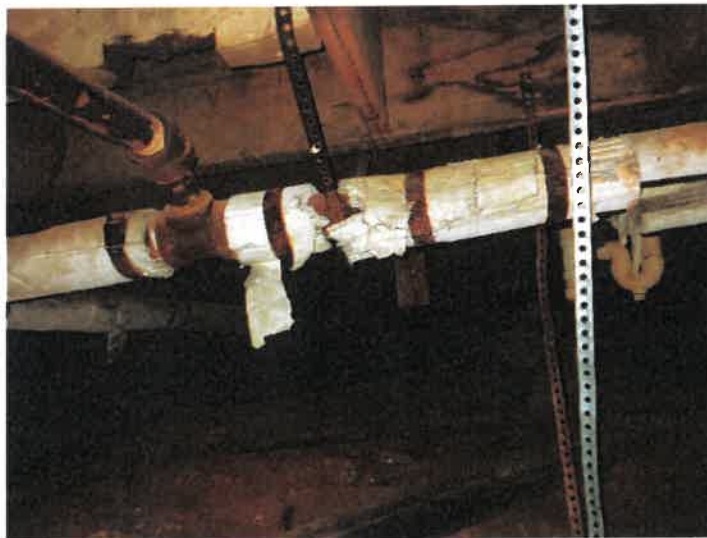
- **Thermal System Insulation – Aircell Pipe Insulation**
  - **Located in basement - may be in walls and crawlspaces.**
    - **THIS MATERIAL IS FRIABLE**
    - **THIS IS A HIGH CONTENT ACM**
    - **THIS MATERIAL IS DAMAGED**
- **Caulk on Exterior Stairwell Entrance**
- **Cement Board Storefront panels**
- **Window Glazing – Original Windows**
- **Caulk on 2<sup>nd</sup> Floor Windows**
- **Cement on Pipe – by Rear Entrance**
- **Door Framing – Basement Entrance**
- **Linoleum – Green – 2<sup>nd</sup> Floor**
- **Tile Mastic on Floor Tile in Old Generator Room**
- **Tile Mastic on Floor Tile in Bathroom**
- **Tan Floor Tile – Basement**
- **White Floor Tile under carpet**
- **Tile Mastic on White Floor Tile under carpet**
- **All 9” X 9” Floor Tile\***
- **All Tile Mastic on 9” X 9” Floor Tile <sup>1</sup>**

**The Aircell Thermal System Insulation was found to be Asbestos  
Containing by the laboratory.**

**THIS MATERIAL IS FRIABLE  
THIS MATERIAL IS DAMAGED  
THIS IS A HIGH CONTENT ACM**

These asbestos containing materials should be removed prior to renovation or demolition activities at this location, if it is to be disturbed. Removal should be performed by licensed, contract personnel using approved methods.

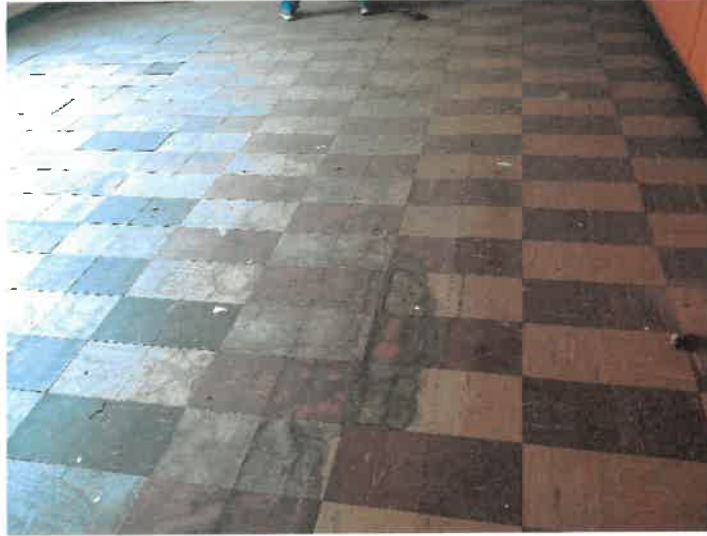
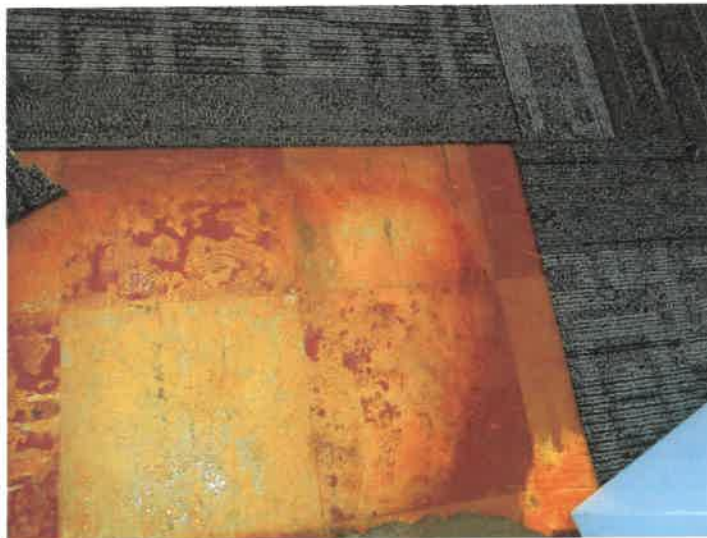
<sup>1</sup> Several colors of 9” X 9” Floor Tile were encountered during the course of the survey. In an effort to reduce the costs associated with testing, most of these materials were ASSUMED to be Asbestos Containing, but some were sampled. All of the 9” floor tile sampled was found to be Asbestos Containing by the laboratory, therefore all 9” floor tile is to be treated as Asbestos Containing.

**All 9" X 9" Floor Tile and Associated Black Mastic was either found to be Asbestos Containing by the laboratory or is ASSUMED to be Asbestos Containing.**

**This material may be located under carpets or other flooring.**

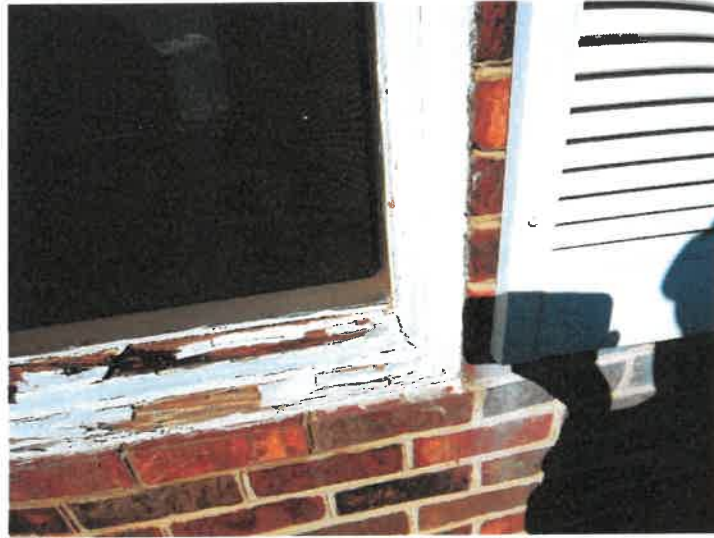
**The window glazing on the original windows of the Elliot Building were found to be Asbestos Containing by the laboratory.**

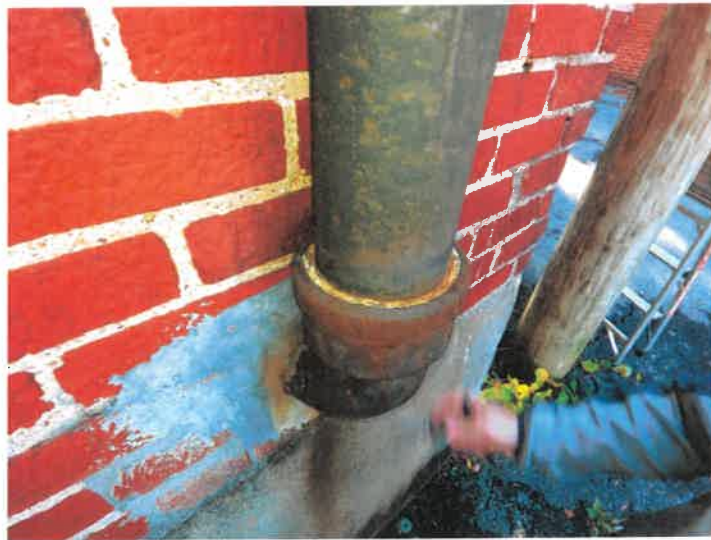
**The cement on a pipe on the back side of the Elliot Building was found to be Asbestos Containing by the laboratory.**

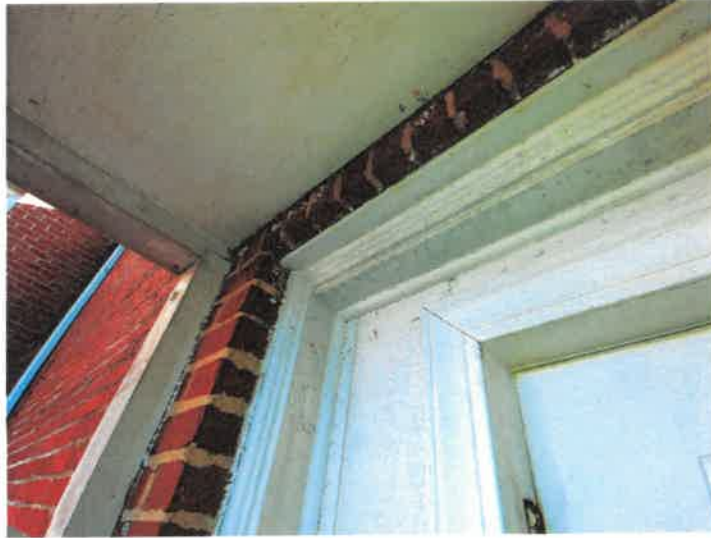
**The door framing on the back side of the Elliot Building was found to be Asbestos Containing by the laboratory.**

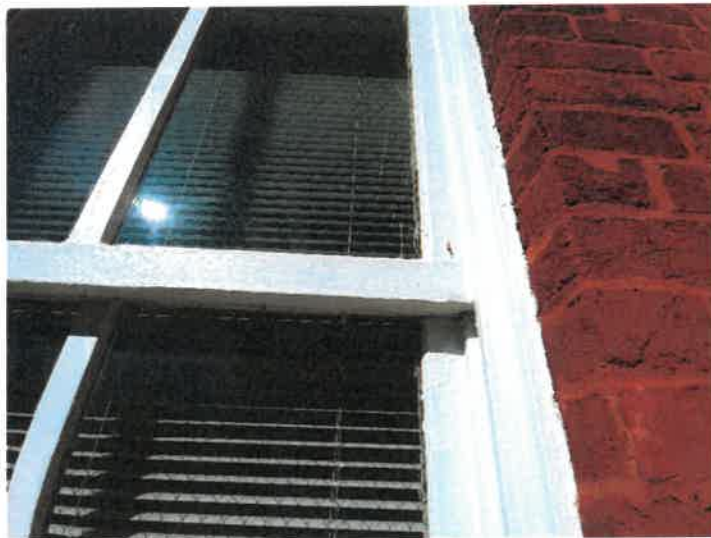
**The window framing on the original courthouse windows was found to be Asbestos Containing by the laboratory.**

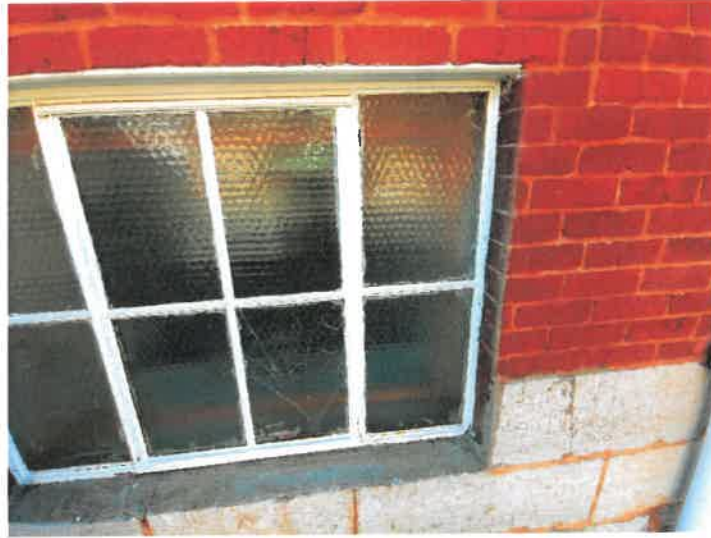
**The window framing on the metal framed windows was found to be Asbestos Containing by the laboratory.**

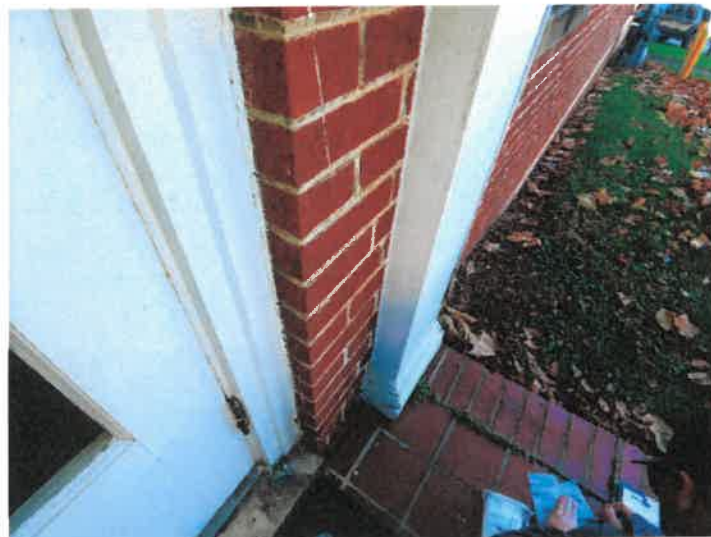
**The door framing on the side entrance (Court Street Side) was found to be Asbestos Containing by the laboratory.**

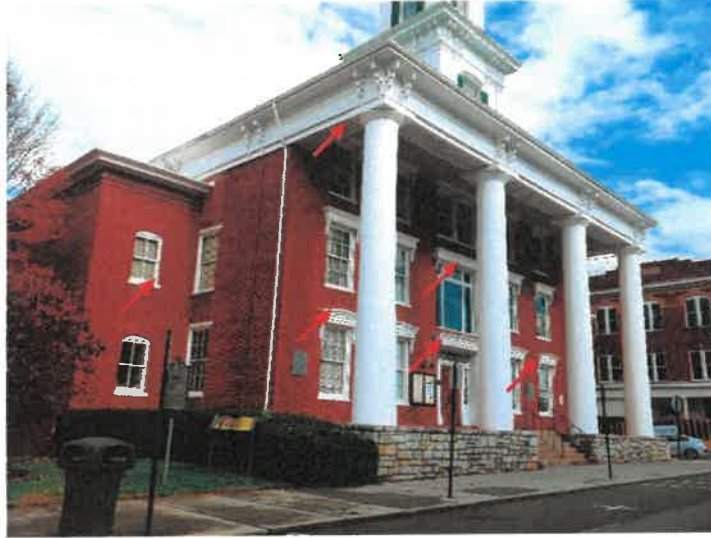
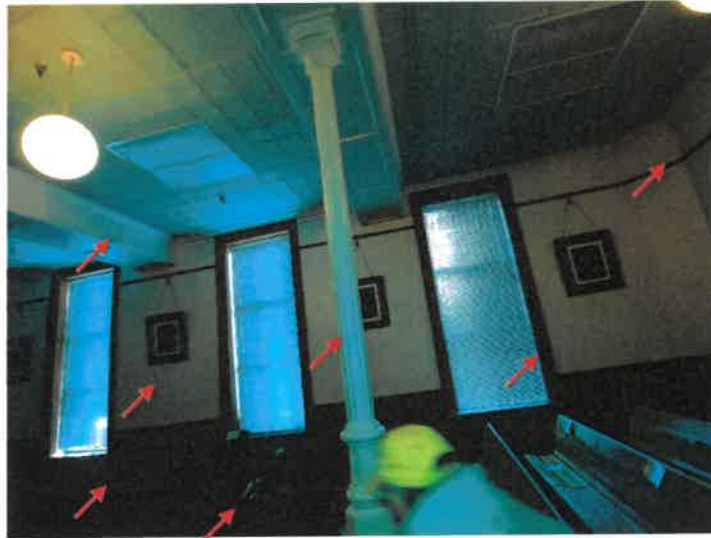
<sup>2</sup> In the original courthouse building, sections (or portions of sections) of trim, door components, window components, and other painted components have been repaired or replaced. XRF Readings for some of these components were negative, while a similar reading on the same component had a positive result. Because these repaired sections are difficult to discern from original components, all of these components are to be considered to utilize lead-based paint.

**In the historic portion of the courthouse, every painted surface, both interior and exterior, was found to utilize lead-based paint.**

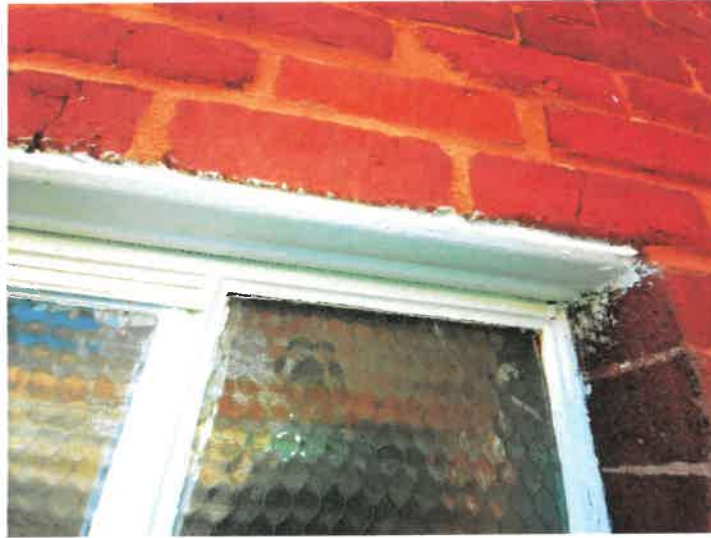
**Metal framed basement window components, including lintels, were found to utilize lead-based paint.**

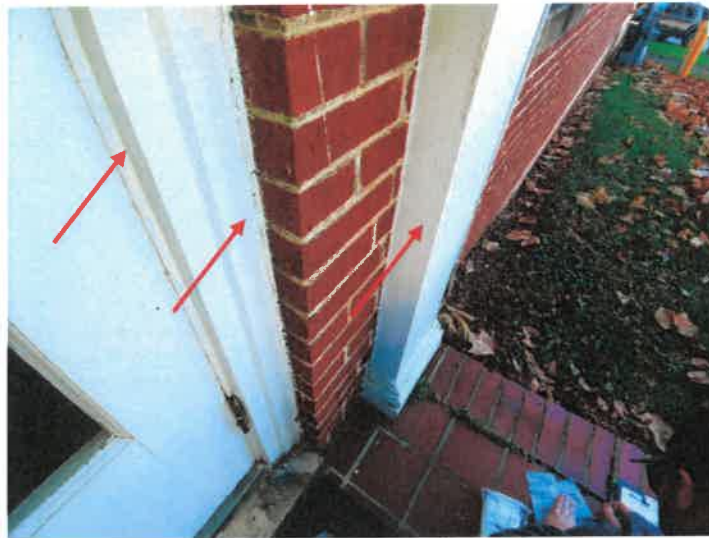
**Painted columns and door components on Court Street entrance were found to utilize lead-based paint.**

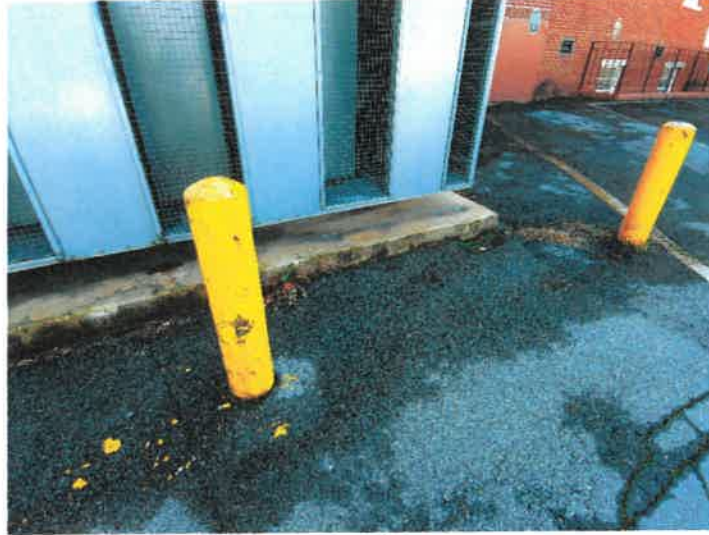
**The traffic bollards were found to utilize lead-based paint.**

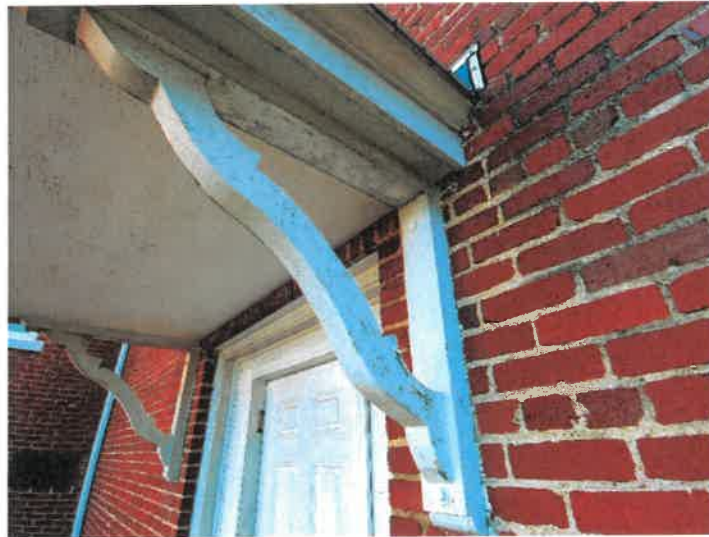
**Painted fascia, soffit and trim on the back side of the Elliot Building were found to utilize lead-based paint.**

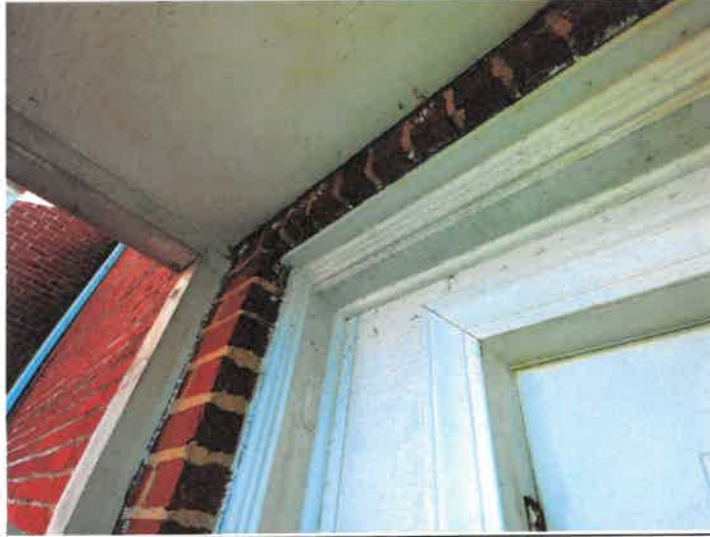
**Window and door lintels on the back side of the Elliot Building were found to utilize lead-based paint.**

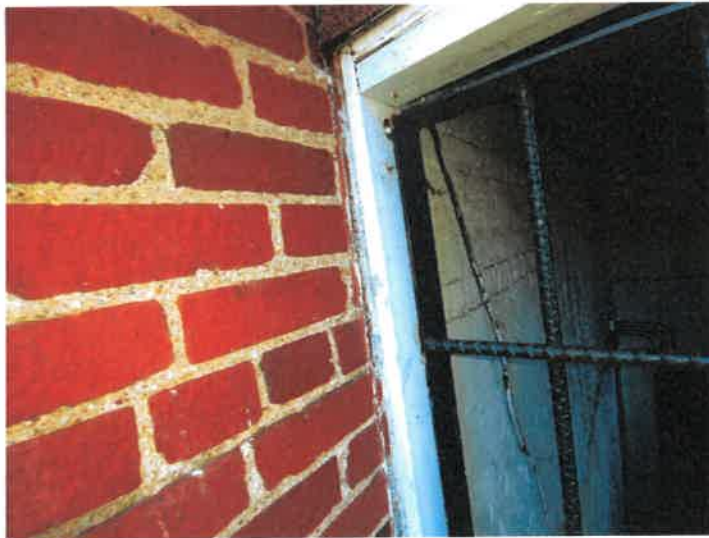
**Painted wood door casings on the Plumb Alley side of the Elliot Building were found to utilize lead-based paint.**

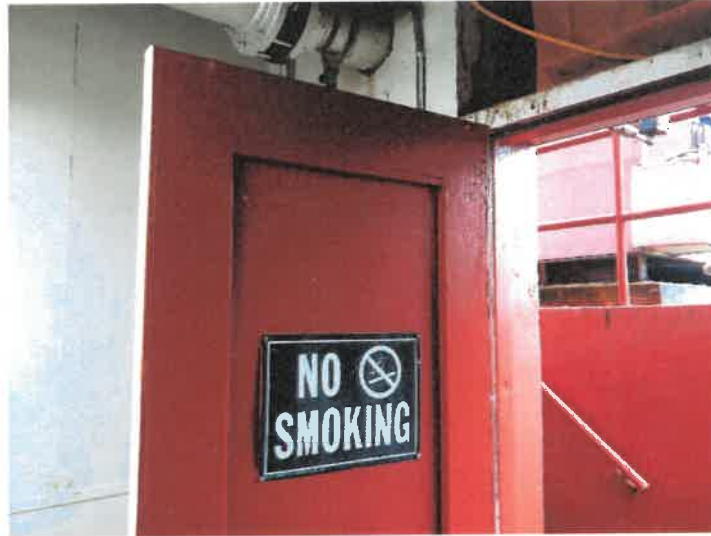
**The painted door components and handrails on the Plumb Alley side (basement) were found to utilize lead-based paint.**

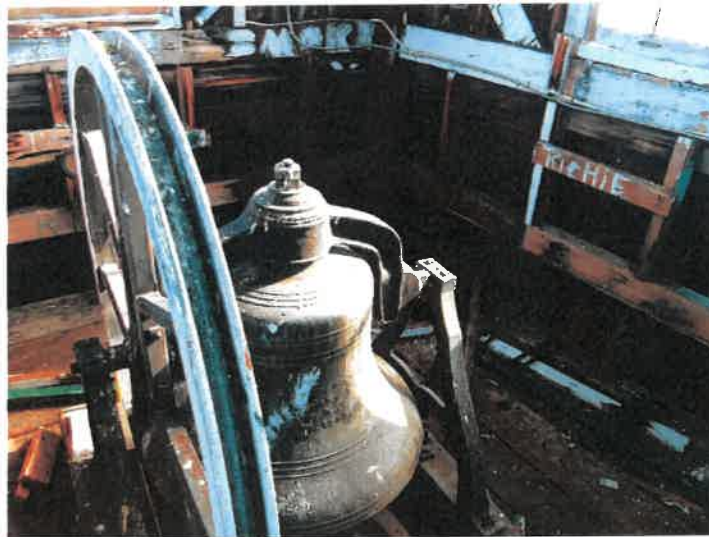
**All painted surfaces in the Bell Tower, including the bell mechanism itself, were found to utilize lead-based paint.**

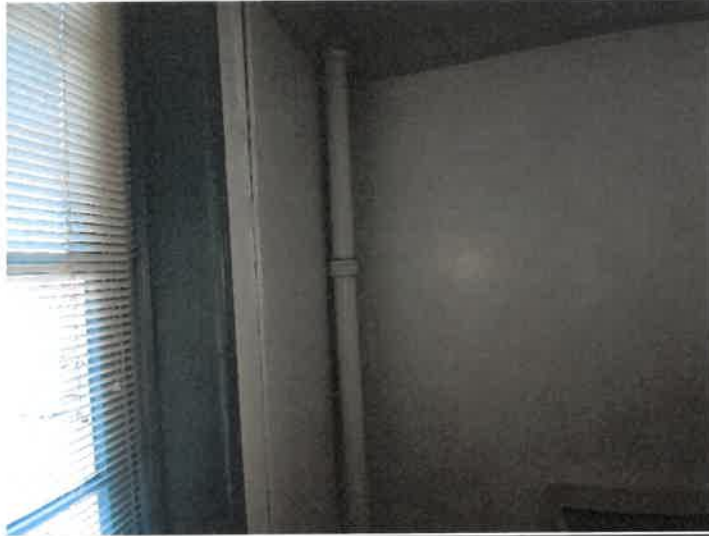
**The interior roof drain pipes were found to utilize lead-based paint.**

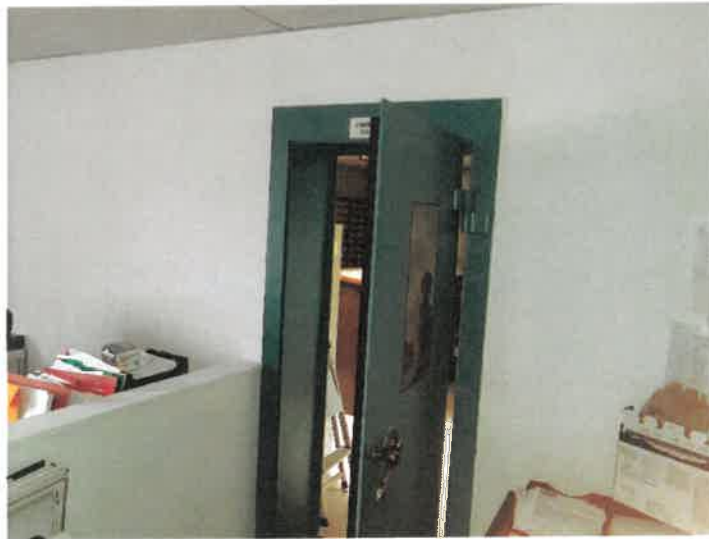
**All vault style doors and door casings were found to utilize lead-based paint.**

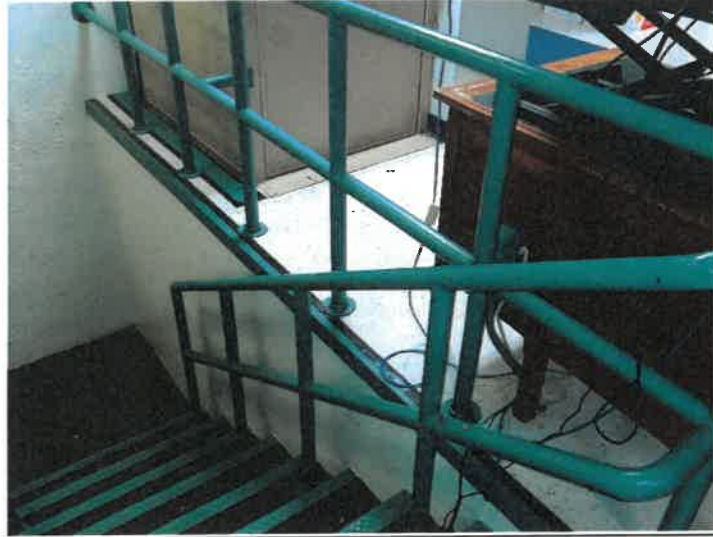
**The painted metal stair railings and stringers were found to utilize lead-based paint.**

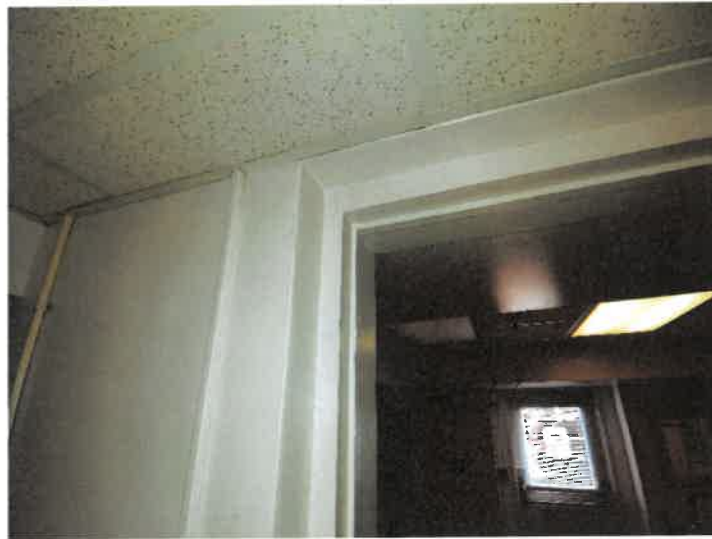
**In the historic original portion of the courthouse basement all painted doors, door casings and window casings were found to utilize lead-based paint.**

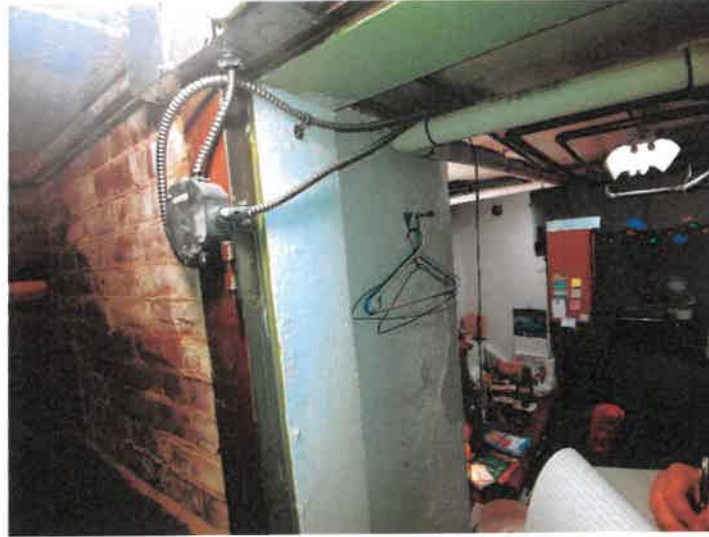
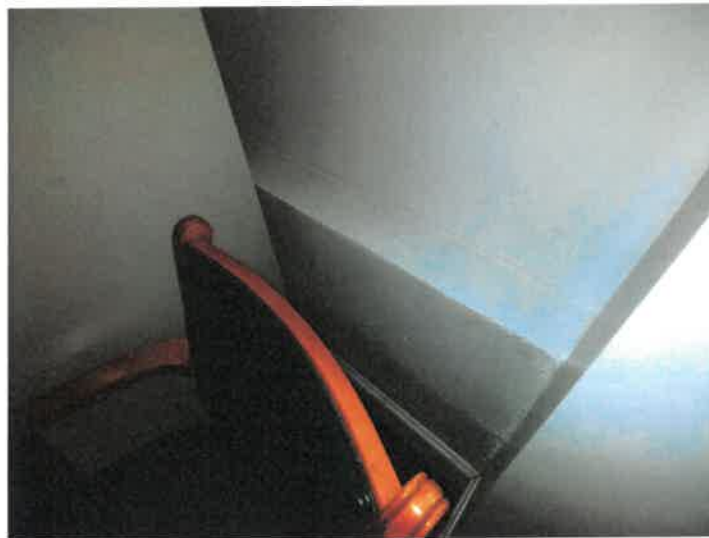
**In the historic original portion of the courthouse basement all painted doors, door casings and window casings and painted concrete walls were found to utilize lead-based paint.**

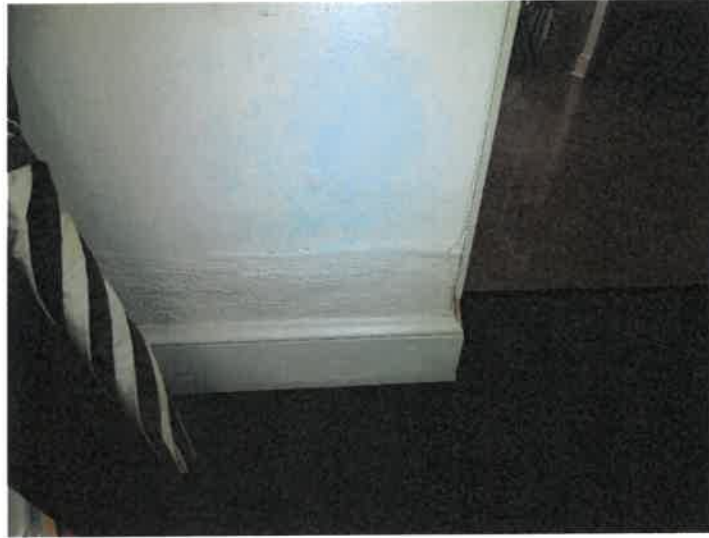
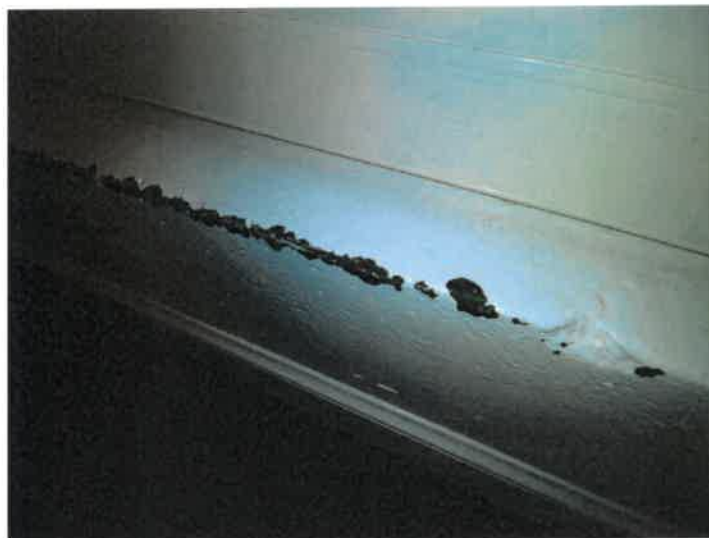
**In the historic original portion of the courthouse basement all painted doors, door casings and window casings and painted concrete walls were found to utilize lead-based paint. This paint is damaged and chipping on the concrete foundations in some places.**

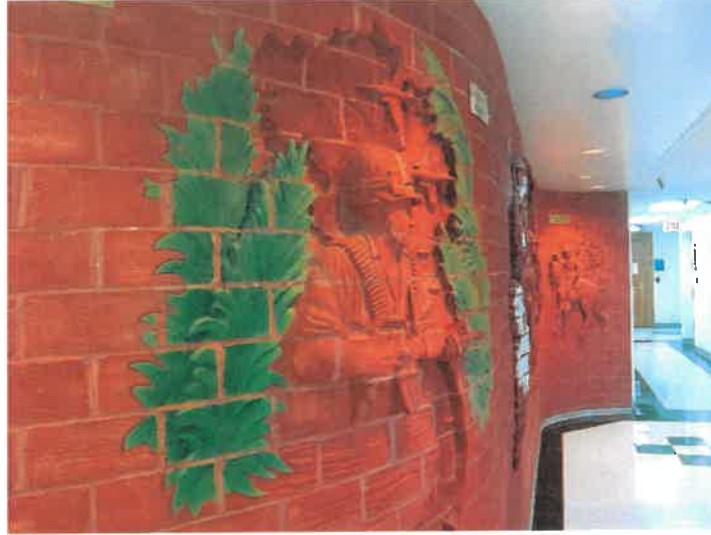
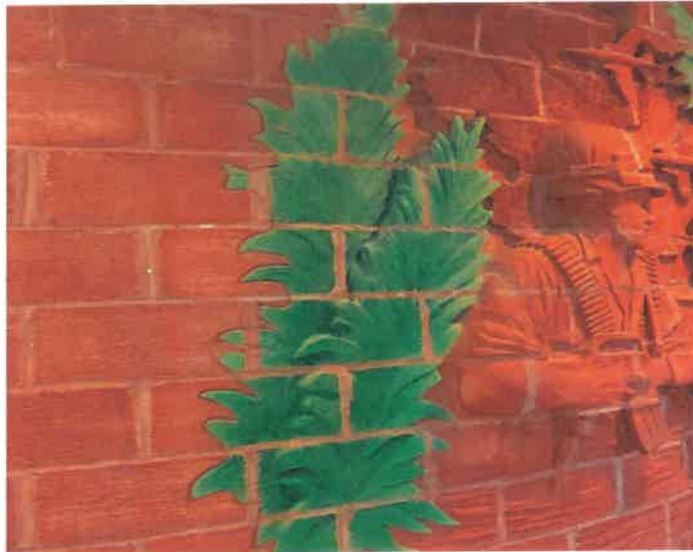
**In the brick artwork located in the main entrance foyer, the green paint was found to be lead-based.**

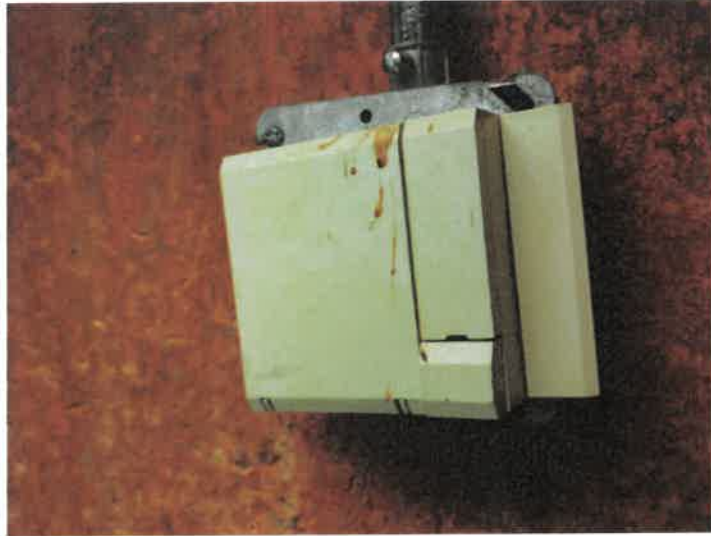
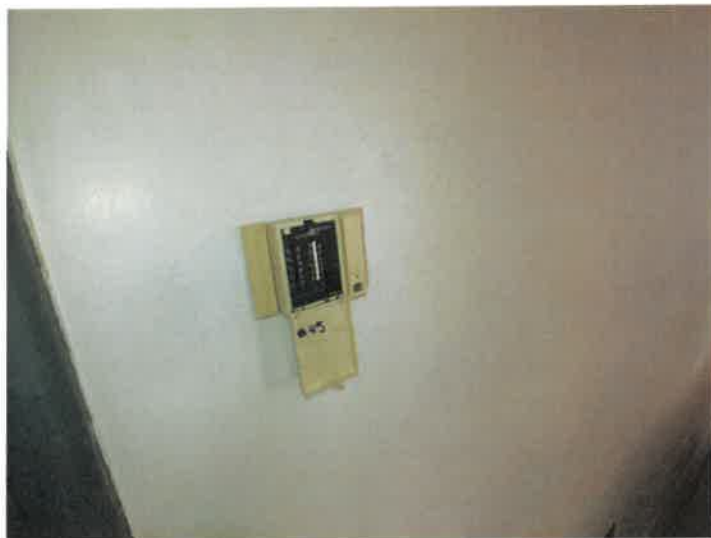
The wall mounted thermostats located in various locations appeared to contain mercury thermometers. Although some units have been replaced with more modern digital or electronic thermostats, the transition did not appear to be universal. Older style thermostats and controls should be assumed to contain mercury. This material may be present in the fixtures throughout the facility. This can be visually verified in individual units by the presence of small glass tubes containing a silver or red liquid.

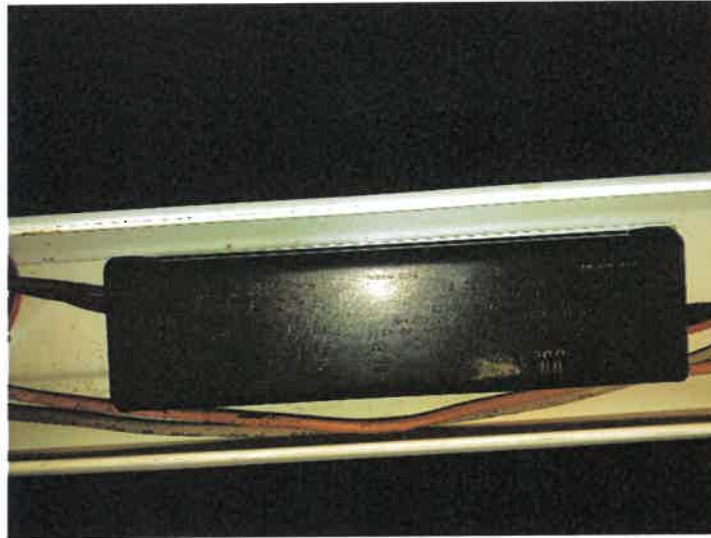
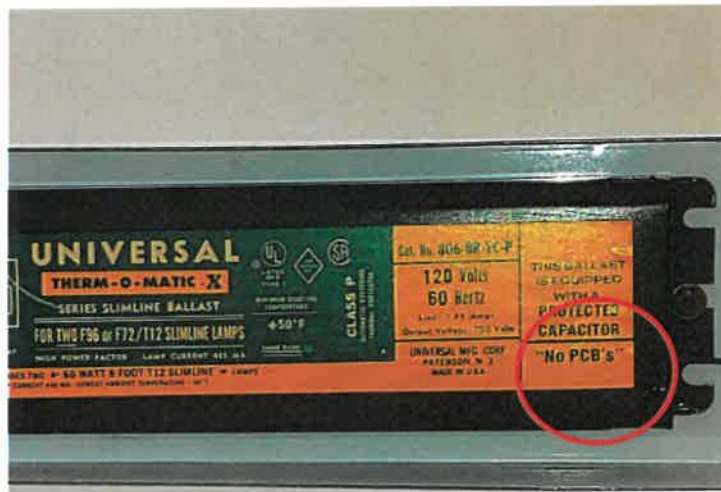
There were several different types of light fixtures throughout the facility. Various units were partially dismantled to identify the “No PCBs” label. Most of the units checked either contained the “No PCBs” label or the ballast had been replaced with LED units. There were older fixtures observed in both the Elliot Building spaces as well as older parts of the original courthouse building. The several different types of fixtures in the facility would have to be dismantled to observe the ballast in each for the determination of whether they are labeled NON-PCB.
